NEW ZEALAND  
LAND AND GROUNDWATER  
CONFERENCE 2024  
22 - 24 OCTOBER - AUCKLAND

# Community Lane Re-Development

Simon Hunt (EHS Support  
New Zealand Ltd) and  
Andrew Rose (Kāinga Ora—  
Homes and Communities)

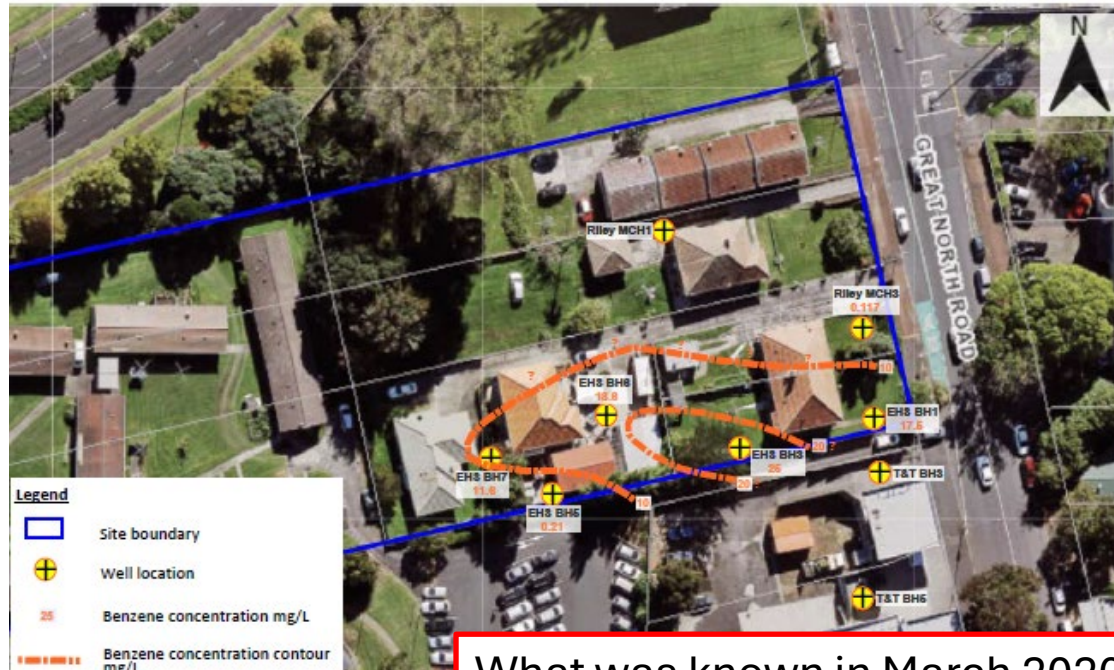
# Extent of BTEX Groundwater Contamination

What was known in March 2020

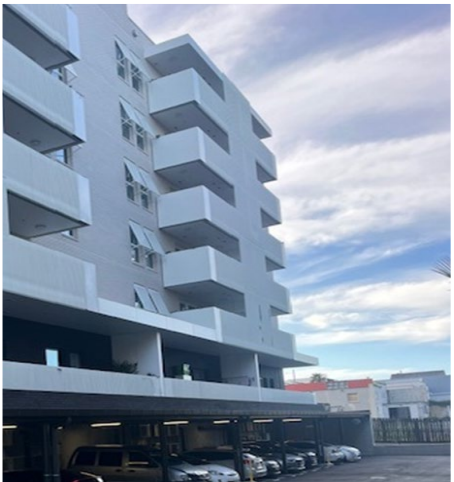
# Building E - Mitigation

- Residual Geology – approx. 1.5 m clay, overlying peat.
- Groundwater – confined conditions, base of confining layer 1.5 m below floor slab.
- Contamination – LNAPL, soil, dissolved + vapour.
- Ground floor use – below-ground car park.
- Mitigation:
  - Clay substrate.
  - Underside of floor slab – bentonite.
  - Lift pit tanked – bentonite.
  - Vented below-ground car park.

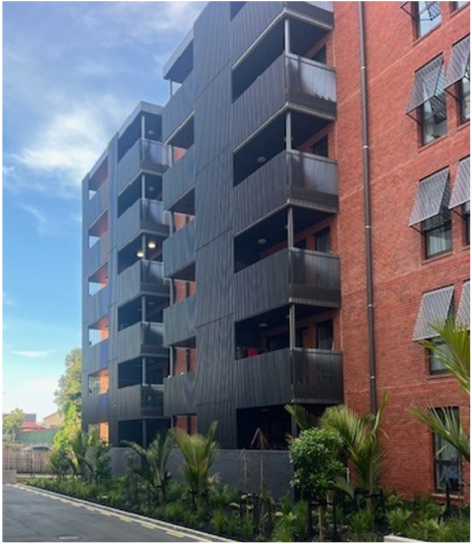
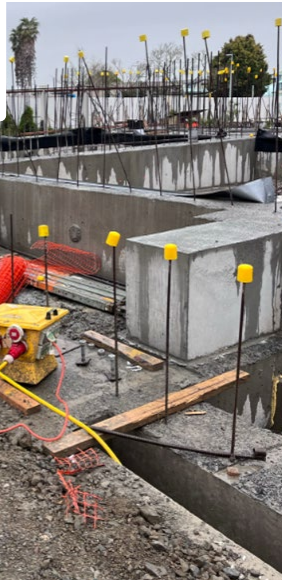
# Building D - Mitigation

- Residual Geology – zero to 1 m clay, overlying peat.
- Groundwater – unconfined/confined, groundwater table 2 m below the floor slab level.
- Contamination – soil, dissolved + vapour.
- Ground floor use – high-density residential.
- Mitigation:
  - 1.5 m gravel blanket – engineered venting through barometric pumping (generate an oxygen-rich environment – supports risk assessment assumptions).
  - Lift pit tanked – bentonite.
  - Active venting/air conditioning in ground floor apartments (managed by Kāinga Ora).

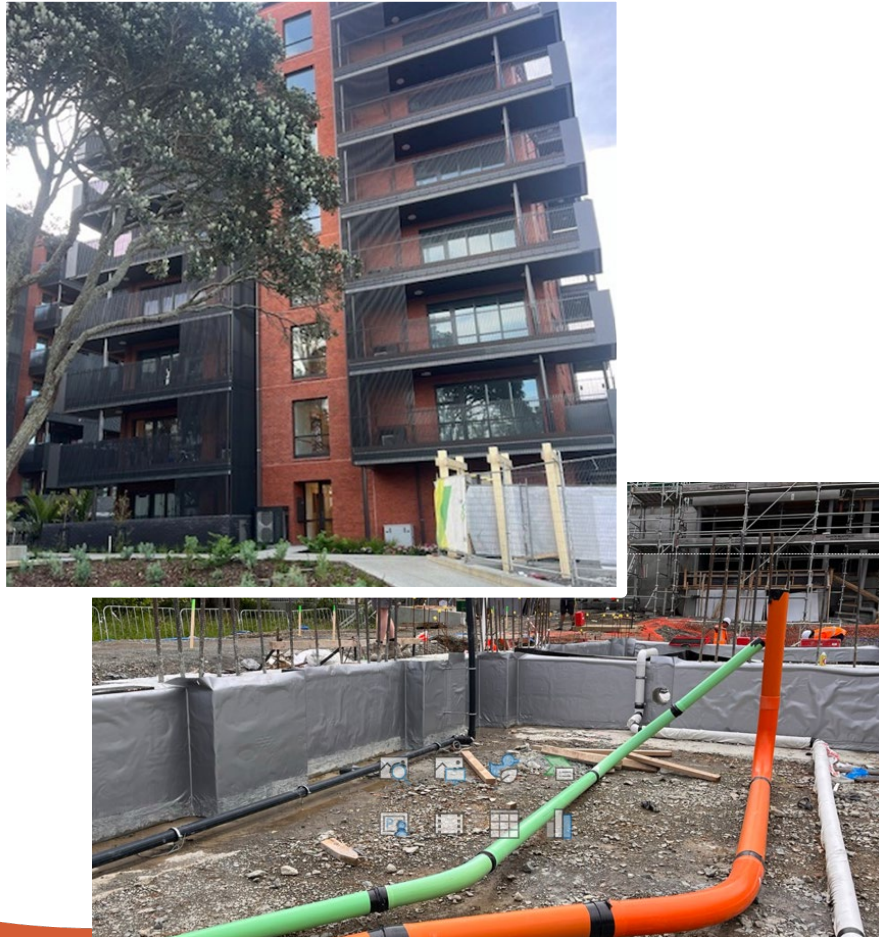
# Building C - Mitigation

- Residual Geology – 1 m granular fill below floor slab level, overlying silty sand.
- Groundwater – unconfined, 1 m below floor slab level.
- Contamination – soil, dissolved + vapour.
- Ground floor use – high-density residential.
- Mitigation:
  - Verified vapour barrier.
  - Engineered passive venting below vapour barrier.
  - Lift pit tanked – bentonite.
  - Active venting/air conditioning in ground floor apartments (managed by Kāinga Ora).
